**Journal of Artificial Intelligence and Digital Business (RIGGS)**

## Hydraulic Valve Failure Analysis at MT. Beyond Using the FMEA Method

*Hydraulic valve failure on a tanker can significantly impact operational performance and shipping safety. This study aims to analyze the causes, impacts, and solutions to hydraulic valve failure on the MT. Beyond. The method used was a qualitative descriptive approach, with data collection techniques through observation, interviews, and documentation studies. Data analysis was performed using the Fishbone Diagram method to identify root causes and Failure Mode and Effects Analysis (FMEA) to evaluate the level of failure risk based on severity, occurrence, and detection parameters. The results showed that hydraulic valve failure was influenced by human, machine, material, method, and environmental factors, with the dominant causes being operational errors, low component quality, fluid contamination, and lack of maintenance. The FMEA analysis showed that the key components with high risk were the disc and seat, which had the highest Risk Priority Number (RPN) values of 162 and 132, respectively. Failure of these components can cause uncontroll

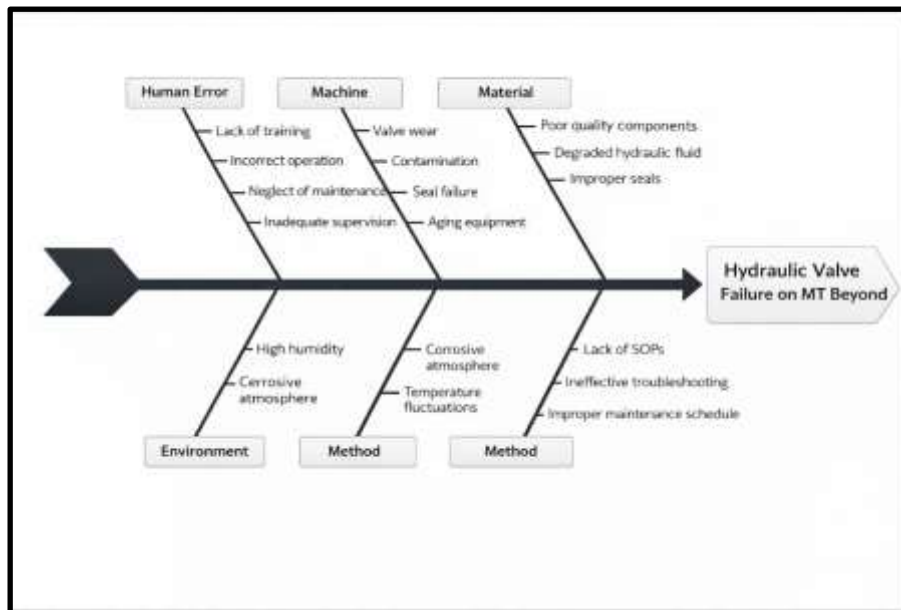
Picture 2. Fishbone Diagram of Factors Causing Hydraulic Valve Failure on the MT Beyond  
 Source: Data Analysis Results (2024)

The identification results indicated that machine and material factors were the dominant causes of failure, with low valve quality and hydraulic fluid contamination being the highest contributors, respectively. Furthermore, method factors also contributed significantly, particularly inconsistent maintenance schedules and non-standard operating procedures. Environmental factors, such as corrosion due to sea conditions, were also significant causes. Fishbone diagram analysis confirmed that hydraulic valve failure resulted from a complex interaction of these factors, requiring a comprehensive repair approach.

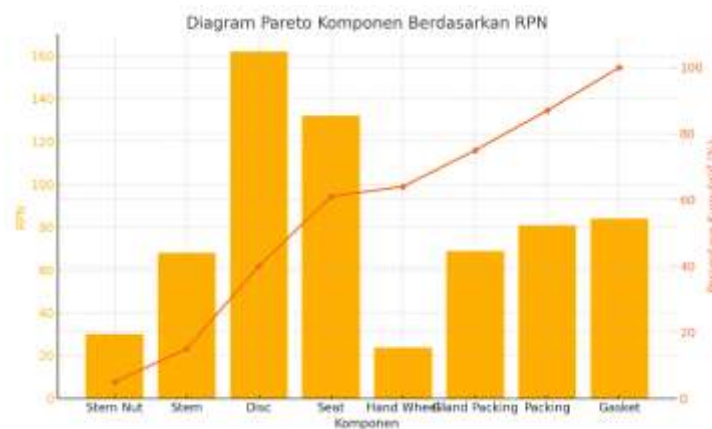
Figure 3. Hydraulic Gate Valve Pareto Diagram Graph

Figure 3 shows the Pareto diagram, which demonstrates the failure risk analysis based on the Risk Priority Number (RPN) for the components of a Hydraulic Gate Valve. The disc component has the highest RPN (162), contributing approximately 25% of the total risk. This is followed by the seat (20%), gasket (13%), and packing (12%). These components contribute the largest share of the system's failure risk.

The red line. The diagram indicates that approximately 40% of the total failure risk comes from the disc component, while approximately 87% of the cumulative risk comes from the five main components: the disc, seat, gasket, packing, and gland packing. The component with the lowest RPN, such as the handwheel, accounts for only 4% of the total risk. These findings align with FMEA theory, which states that a small number of components often contribute significantly to the risk in a system. Therefore, improvement priorities are focused on components with the highest RPN values through improving material quality, regular maintenance, and controlling fluid contamination. These results are also consistent with previous research emphasizing the importance of preventive maintenance and operational condition control in improving hydraulic system reliability.
