Journal of Artificial Intelligence and Digital Business (RIGGS)

Analysis of Watchkeeping Implementation During Cargo Lifting Operations to Avoid Collision with Rig Legs: A Case Study of AHTS Logindo

Idham Abdul Aziz Zulkifli¹, Anak Agung Ngurah Ade Dwi Putra Yuda², Dian Junita Arisusanty³, Samsul Huda⁴
^{1,2,3,4}Politeknik Pelayaran (Polteknip) Surabaya

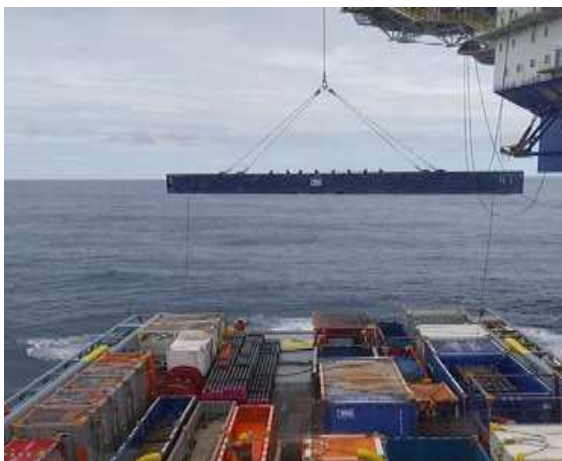
Observation of Risk: During the night operation (21:00), the weather conditions were deteriorating. The log noted "Standby at clear area" for several hours prior, indicating marginal conditions. The re-entry at night, combined with the fatigue of waiting, created a high-risk scenario. The vessel had to back down towards the rig leg to allow the crane to reach the cargo deck. At this moment, the stern was within 15 meters of the rig leg. The bridge team relied heavily on the DP system, while the deck crew were focused on the cargo hook, reducing the effective visual lookout for the rig leg distance. This operational snapshot highlights the convergence of multiple risk factors.

Fig. 1 Cargo Lifting

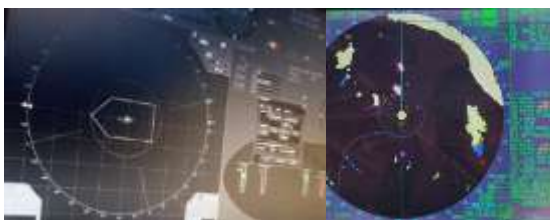
The ship's radar is optimized for open-water detection (3-12 miles). At close quarters (10-50 meters), radar returns from the rig legs can be obscured by "sea clutter" or the vessel's own mast structures (blind sectors).

Finding: Radar is effectively useless for fine-scale positioning relative to a rig leg. The OOW must rely on visual sight lines or CCTV. The CCTV cameras on the *Logindo Stamina*, while present, may have blind spots or be obscured by salt spray/rain, reducing their utility as a primary reference.

Fig. 3 Radar at AHTS Logindo Stamina

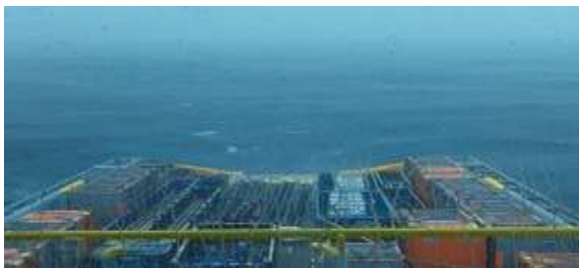
The observation of "Extreme Weather" on Dec 28th highlights the risk. High winds act on the vessel's superstructure (windage), requiring significant thruster power to counteract. If a thruster fails or trips under high load, the wind can drift the vessel into the rig in seconds.

Fig. 4 Bad Weather at Rig Area
