Journal of Artificial Intelligence and Digital Business (RIGGS)

Vol. 5 No. 1 (2026) pp: 4900-4907

The Influence of Puncture Valve Wear on Bosch Pump Pressure and Main Engine Performance: A Quantitative Analysis of KM. Tanto Bersinar

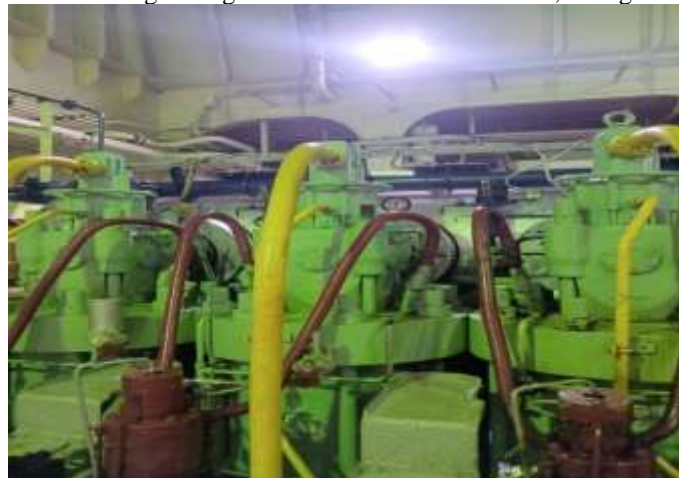
Fig. 4. Exhaust Number 2

- **Exhaust Temperature Collapse:** Despite the rack being at 34 mm, the exhaust temperature for Cylinder 2 plummeted to 100°C. In contrast, the other cylinders maintained a healthy range of 300-305°C. A reading of 100°C is essentially the temperature of the scavenging air after compression without any combustion heat release. This confirms a Total Misfire condition.

- **Cooling Water Drop:** The jacket cooling water outlet temperature for Cylinder 2 dropped to 54°C (normal: 77°C). This thermal drop confirms that no heat was being generated inside the cylinder liner, corroborating the misfire diagnosis.

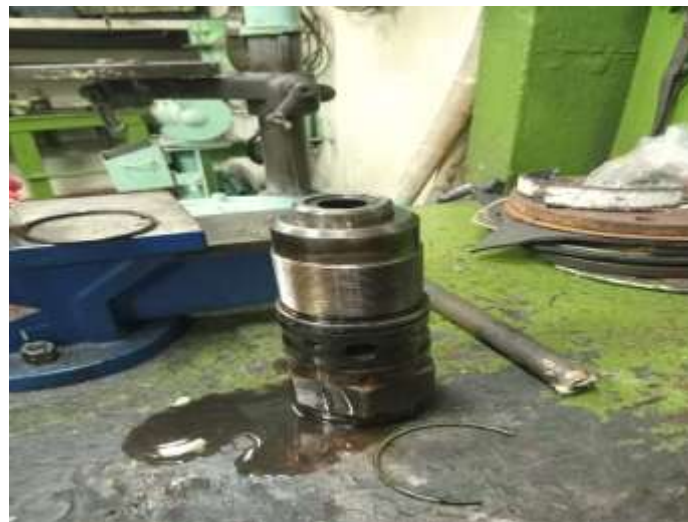
Fig. 6. Broken Puncture Vakce Number 2

Upon disassembly of the Cylinder 2 puncture valve, the following conditions were noted:

- Piston Wear (Component M3): The pneumatic piston exhibited significant abrasive wear. This increases the clearance between the piston and the housing.
- Housing Oversize (Component M1): The housing bore was oversized.
- O-Ring Failure: The sealing O-rings were hardened and flattened, losing their elasticity.

In a healthy Bosch pump, the high-pressure chamber (above the plunger) is sealed. When the plunger rises, pressure builds rapidly to 300+ bar to open the fuel injector. In the failed unit (Cyl 2), the wear in the puncture valve created a continuous path between the high-pressure chamber and the fuel return line.

- The Physics of the Failure: As the plunger rose to compress the fuel, the fuel did not build pressure. Instead, it flowed through the path of least resistance—the leaking puncture valve—back to the circulation line.
- Result: The peak pressure never reached the nozzle opening pressure (320 bar). Consequently, the injector needle remained seated. No fuel was sprayed. The cylinder experienced a complete misfire, explaining the 100°C exhaust temperature.

Buffer Implementation: A safety buffer of 10% (500 hours) should be applied. Puncture valves should be scheduled for overhaul at 4,500 hours rather than 5,000 hours to account for variations in fuel quality and operational stress.

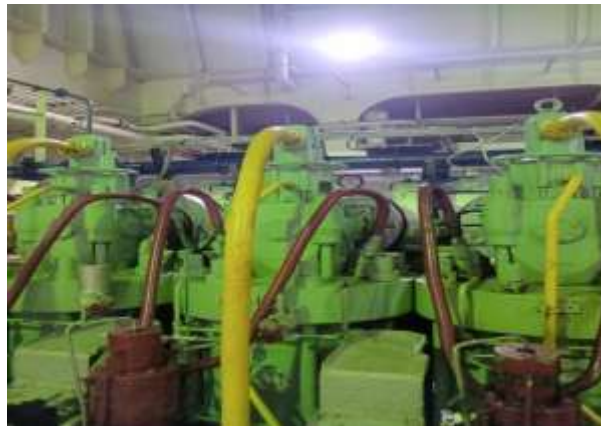
Fig. 7. exhaust number 2 experienced a decrease in temperature
